NASA Contractor Report 159071

Flight Service Evaluation of Kevlar-49, Epoxy Composite Panels in Wide-Bodied Commercial Transport Aircraft

Fifth Annual Flight Service Report

LOCKHEED-CALIFORNIA COMPANY
BURBANK, CALIFORNIA 91520

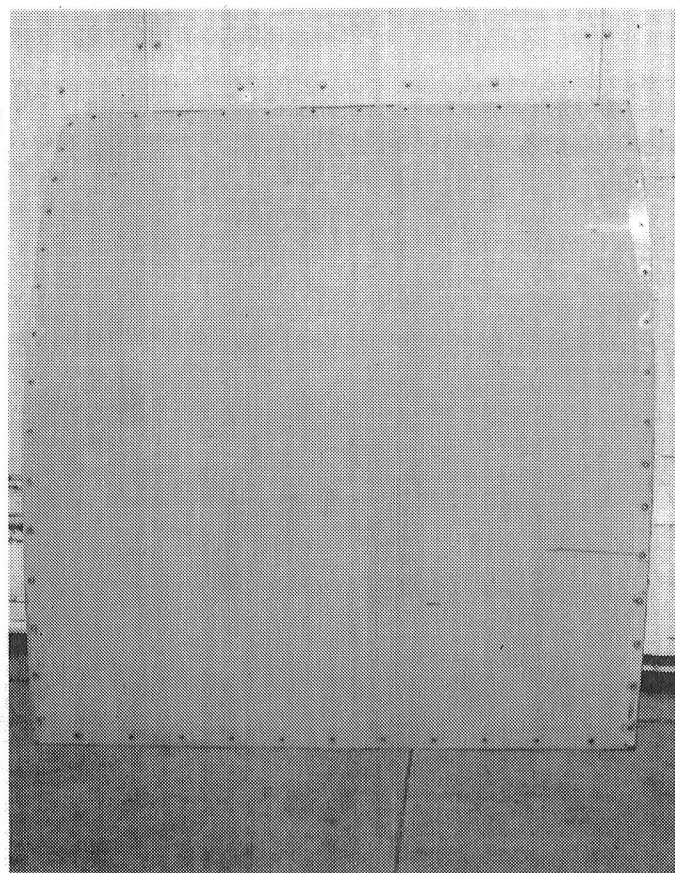
Figure 1. - Eastern left-hand wing-body fairing - exterior.

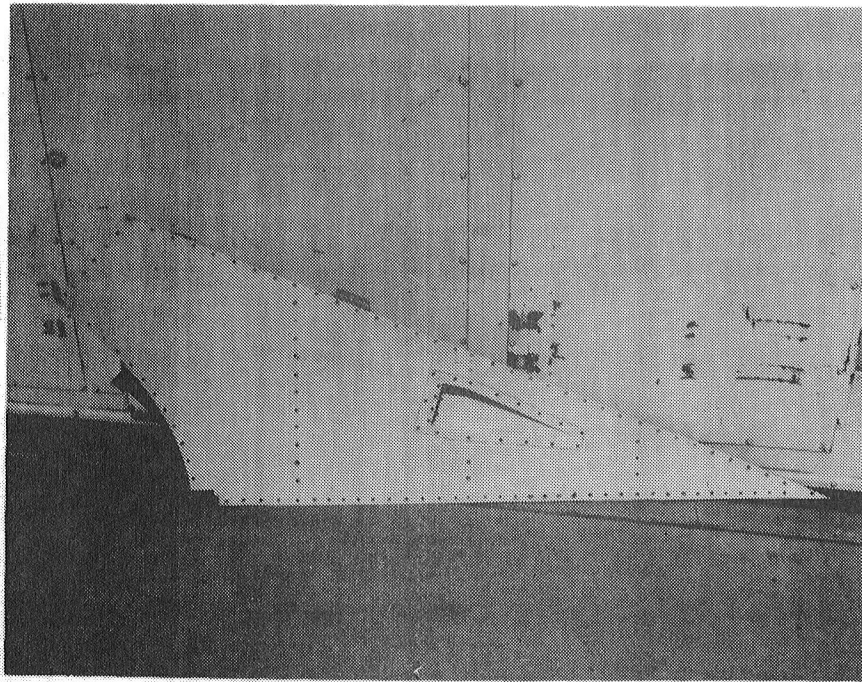
Figure 3. - Eastern left-hand aft engine fairing - exterior.

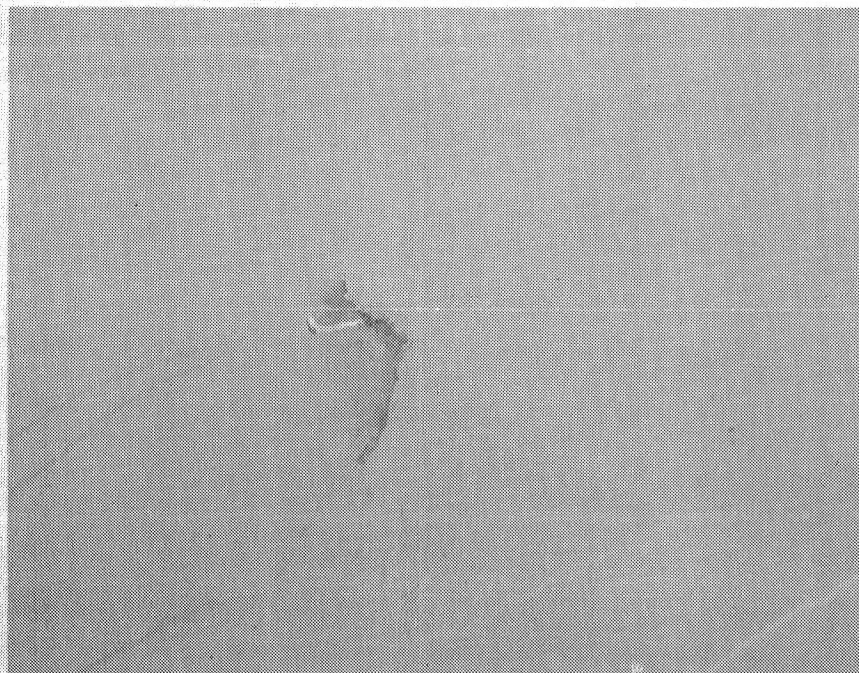
1. The panel weight was 6.9 kg (15.2 lb). The original recorded panel weight was 7.0 kg (15.5 lb).
2. A deep gouge and associated crack was noted in the upper forward area of the exterior surface (figure 4). The maximum depth was 0.06 cm (1/16 in.), and the honeycomb was exposed. The length of this crack was approximately 2.5 cm (1 inch) across the chord from end to end of the crack. There was no associated delamination except immediately adjacent to the crack. This was definitely caused by impact, probably from ground handling.

Figure 4. - Eastern left-hand wing-body fairing - deep gouge and crack with exposed honeycomb, 2.5 cm (1 in.) length.

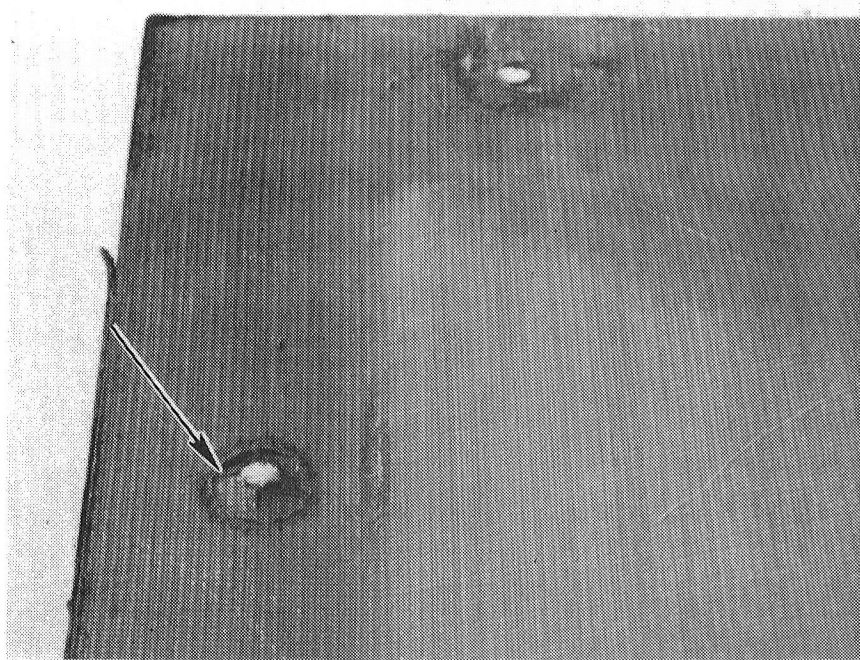
Figure 7. - Eastern left-hand wing-body fairing - elongated hole with convex deformation on lower edge.

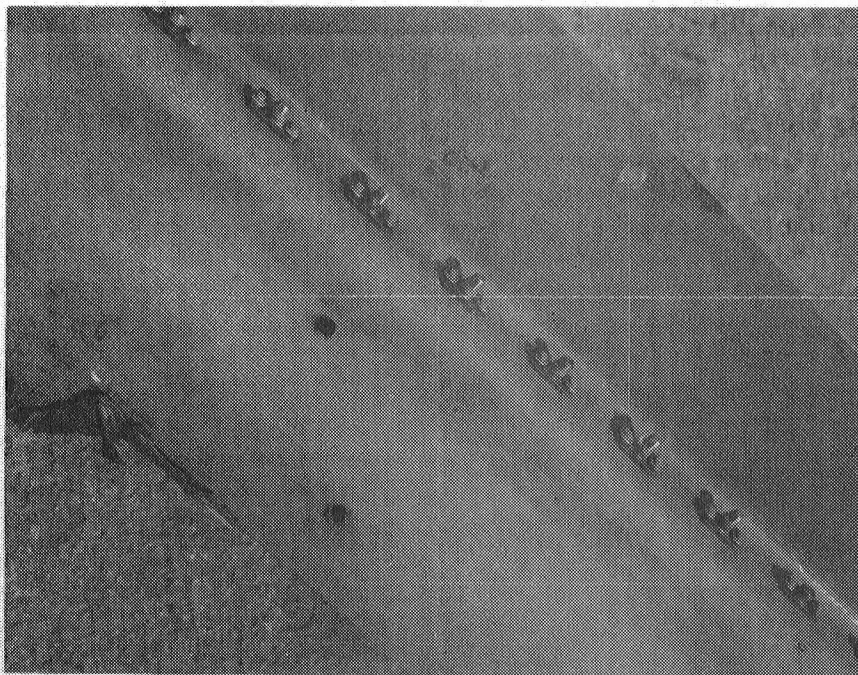
Figure 8. - Eastern left-hand underwing fillet - frayed fastener holes.

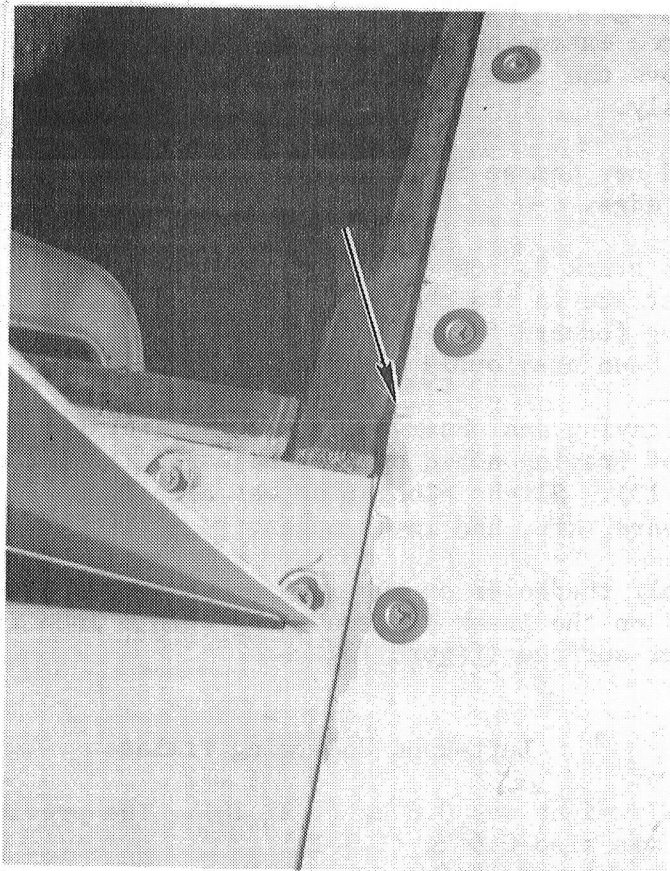
1. Several surface cracks observed in previous inspection were unchanged in appearance or extent:
 - A 1.3 cm (1/2 in.) crack between the fifth and sixth holes from the top along the forward edge (figure 10)
 - A 0.3 cm (1/8 in.) ding in the lower center area
 - A 0.3 cm (1/8 in.) crack in the aft center area

There was no associated disbonds or delamination with these cracks.

Figure 10. - Eastern right-hand wing-body fairing - crack on forward edge 1.3 cm (1/2 in.) length.

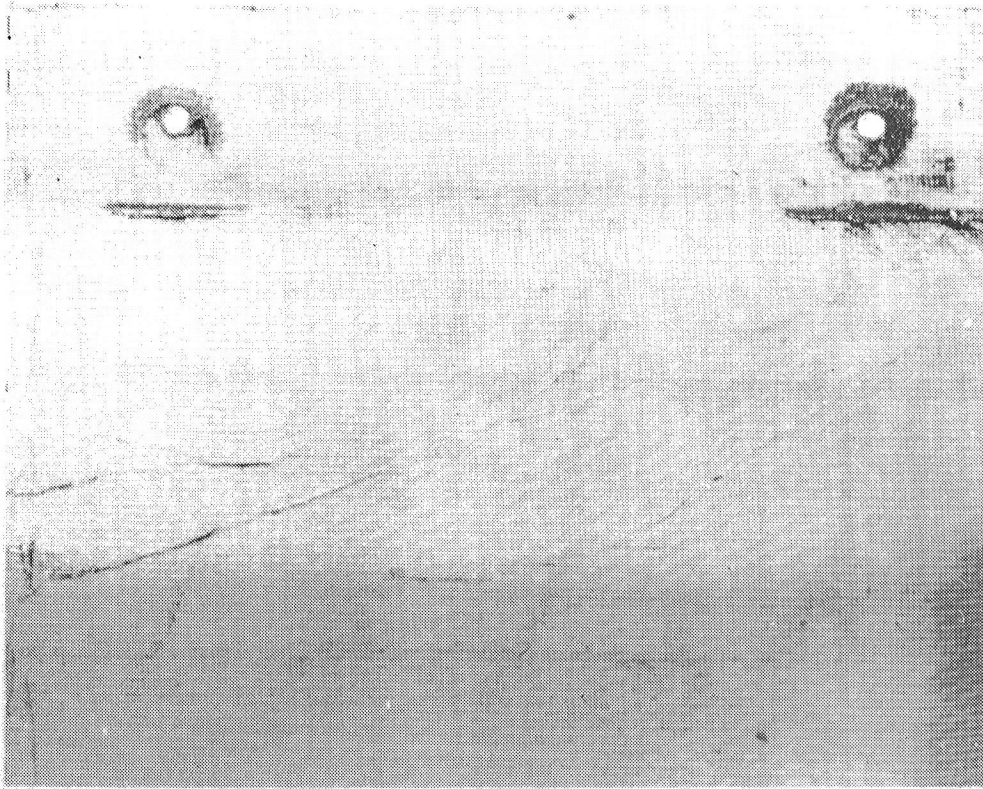
6. Slight fraying was observed on all fastener holes, with the greatest degree of fraying noted on some holes on the aft and lower edges (figure 13). Slight elongation was also noted on several holes on the forward, aft, and lower edges.

Figure 13. - Air Canada left-hand wing-body fairing - frayed fastener holes on lower edge, with deformation and mark-off of laminate around holes.

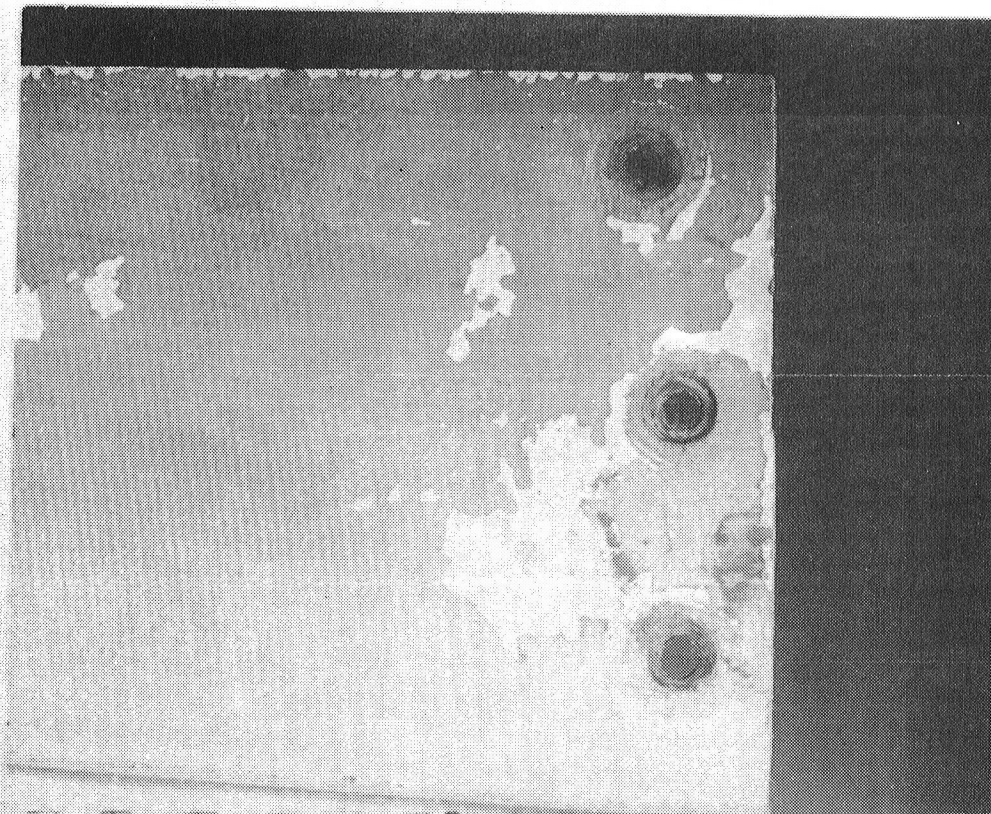
2. The exterior surface had extensive paint loss with the Kevlar-49 surface exposed in the upper area. No damage to the laminate was observed on either surface.
3. Slight fraying was observed in most of the fastener holes (figure 14). Elongation was also observed in most of these holes. Eight of the elongated holes had a significant degree of deformation with elongations to 0.6 cm (1/4 in.) and in one case 0.7 cm (9/32 in.) from the original 0.5 cm (3/16 in.) size (figure 15). These holes had a random distribution on the fairing.

Figure 14. - Air Canada left-hand underwing fillet - typical frayed fastener holes.

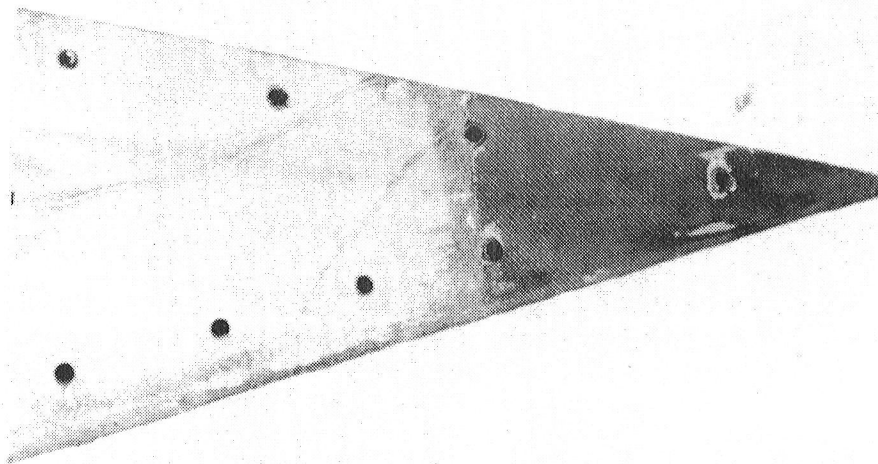
6. Two patch areas at the extreme forward and aft edges of the fairing were unchanged in appearance since originally observed in 1974 (figures 18 and 19). The patches are dark colored and fibrous, and may be some type of electrical tape overcoated with resin.

Figure 18. - Air Canada right-hand aft engine fairing - patch at forward edge.
